STATE OF MAINE DEPARTMENT OF TRANSPORTATION

EXPERIMENTAL CONSTRUCTION 96-25 and 97-19

EXPERIMENTAL USE OF SAWED AND SEALED JOINTS TO MINIMIZE THERMAL CRACKING

Interim Report - Third Year

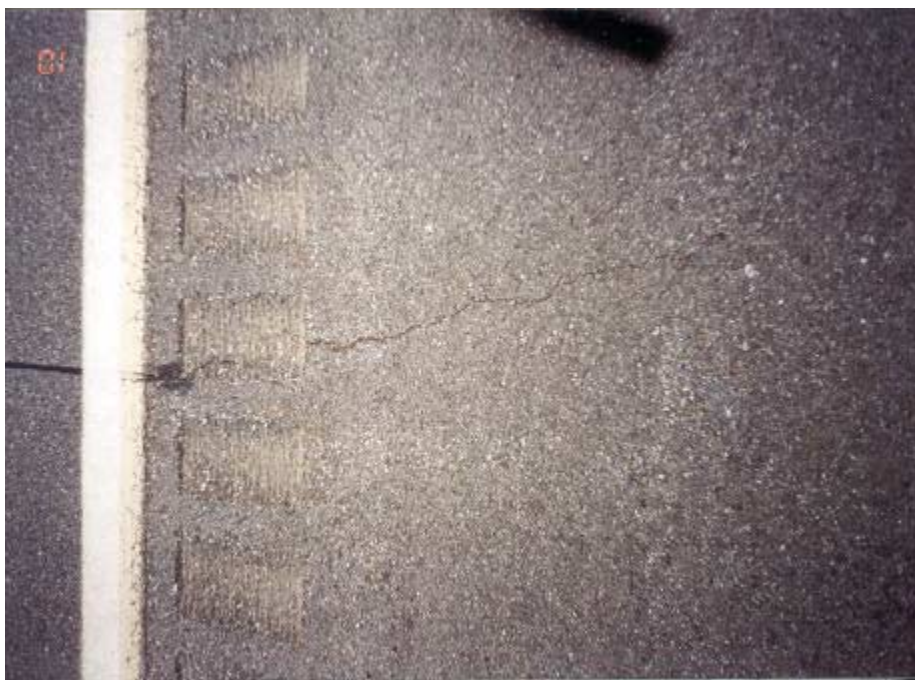
One concern identified during these inspections were cracks extending from the end of the sawed joints into the paved shoulders. This was noticed in each project; however, the T1-R6 project has a much higher number of these cracks and their severity is also greater (see attached photos). Sawed joints were measured and found to be the recommended one-foot into the paved shoulder for the Beddington-Deveraux project. For the T1-R6 project, the sawed joint did not extend into the paved shoulder as recommended. This was probably due to the presence of a rumble strip at the edge of the travel and passing lanes, which limited the sawing process. It appears this may be the cause of the above-mentioned increase in number and severity of these cracks.

Edge of Travel Lane

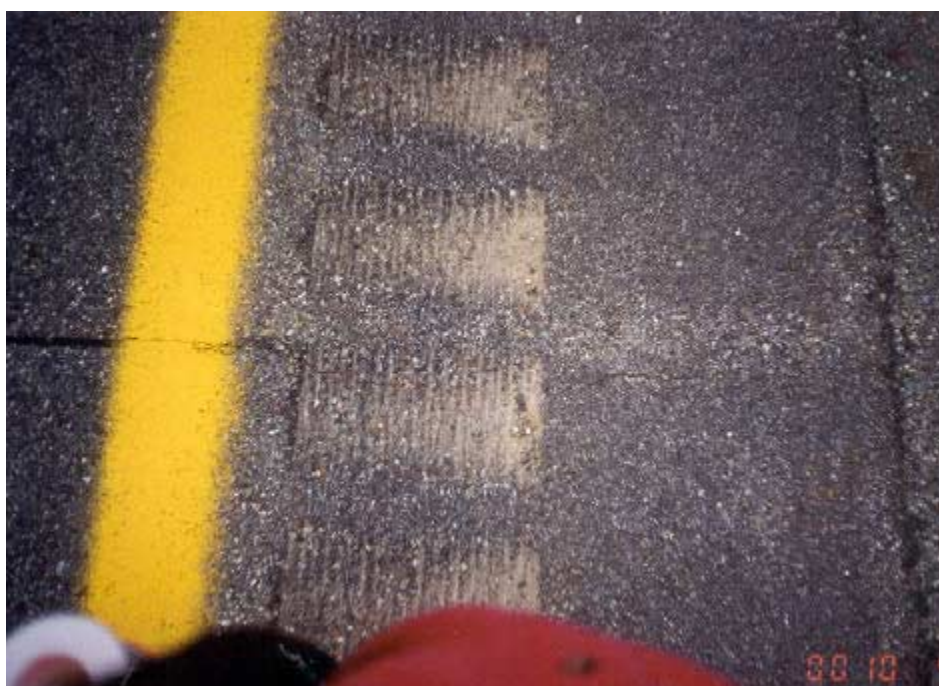
Edge of Passing Lane

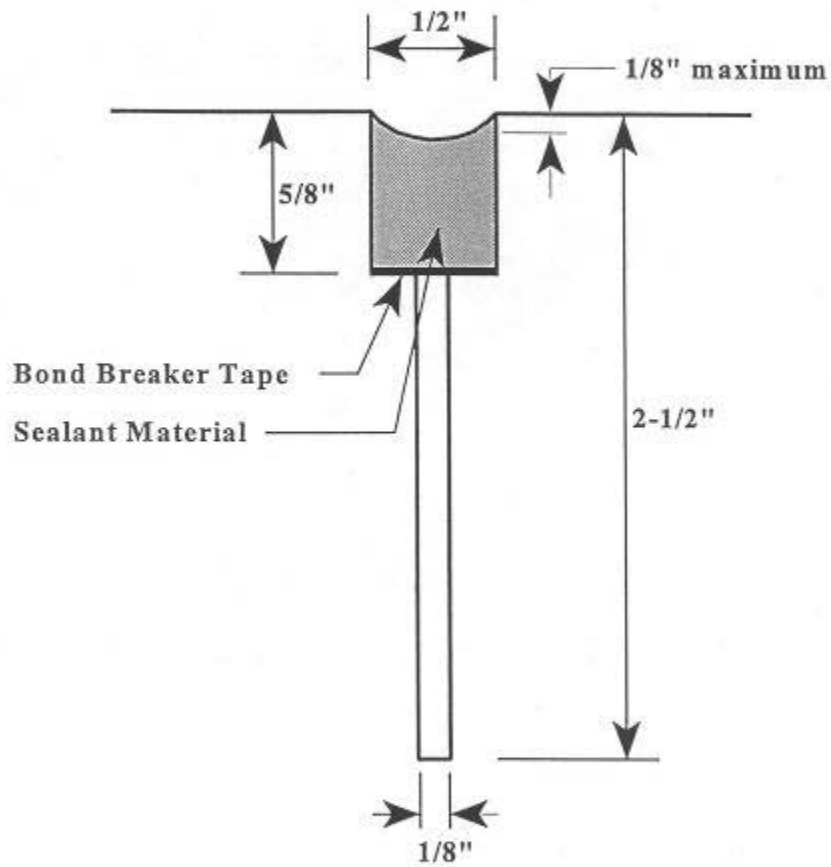
FIGURE I

The construction process, including the bituminous wearing surface was completed in the experimental area September 10, 1997. The Saw and Seal process began October 2, 1997 at station 70+00. Full width joints (including one foot into each paved shoulder) were sawed to a total depth of 2 ½ inches. A reservoir ½ inch wide by 6 inch deep was included to accommodate the sealant (see Figure I). This cutting was accomplished in a single pass using a “wet cut” pavement saw. After the correction of several problems associated with the Sawed and Sealed joints, this experimental feature was successfully completed October 23, 1998. Although air temperatures during this second phase of installation were below the 50-degree minimum, installation was allowed to continue. Bond breaker tape was used in each joint and in some instances a double layer was applied to assure the sealant remained in the reservoir.

Typical Joint Section
